### The Tympanum.

## Mitigation— Fact or Fiction?

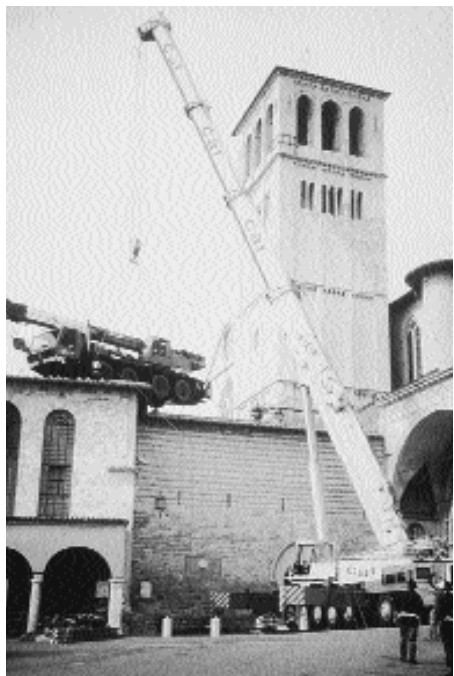
A crane in front of the convent lifts a second crane over the wall into the courtyard.

But such a crane could not pass through the narrow gate into the inner courtyard. This problem was solved using two cranes. The first crane located outside the basilica complex lifted the second

crane over the roof of the building and deposited it in the inner courtyard.

The following emergency stabilization work was completed between October 10-14, 1997. The steel structures were built; two cranes arrived on the square in front of the basilica; the first crane lifted the second one into the courtyard; the two cantilever steel trusses were lifted over the roof of the transept and were anchored to the lateral walls, ready to receive the steel frame.
